TITLE- Command Problems on AS-202,
AS-501 and AS-204/LM-1 Missions

TM- 68-2034-11

DATE-December 31, 1968

AUTHOR(S)- I. I. Rosenblum

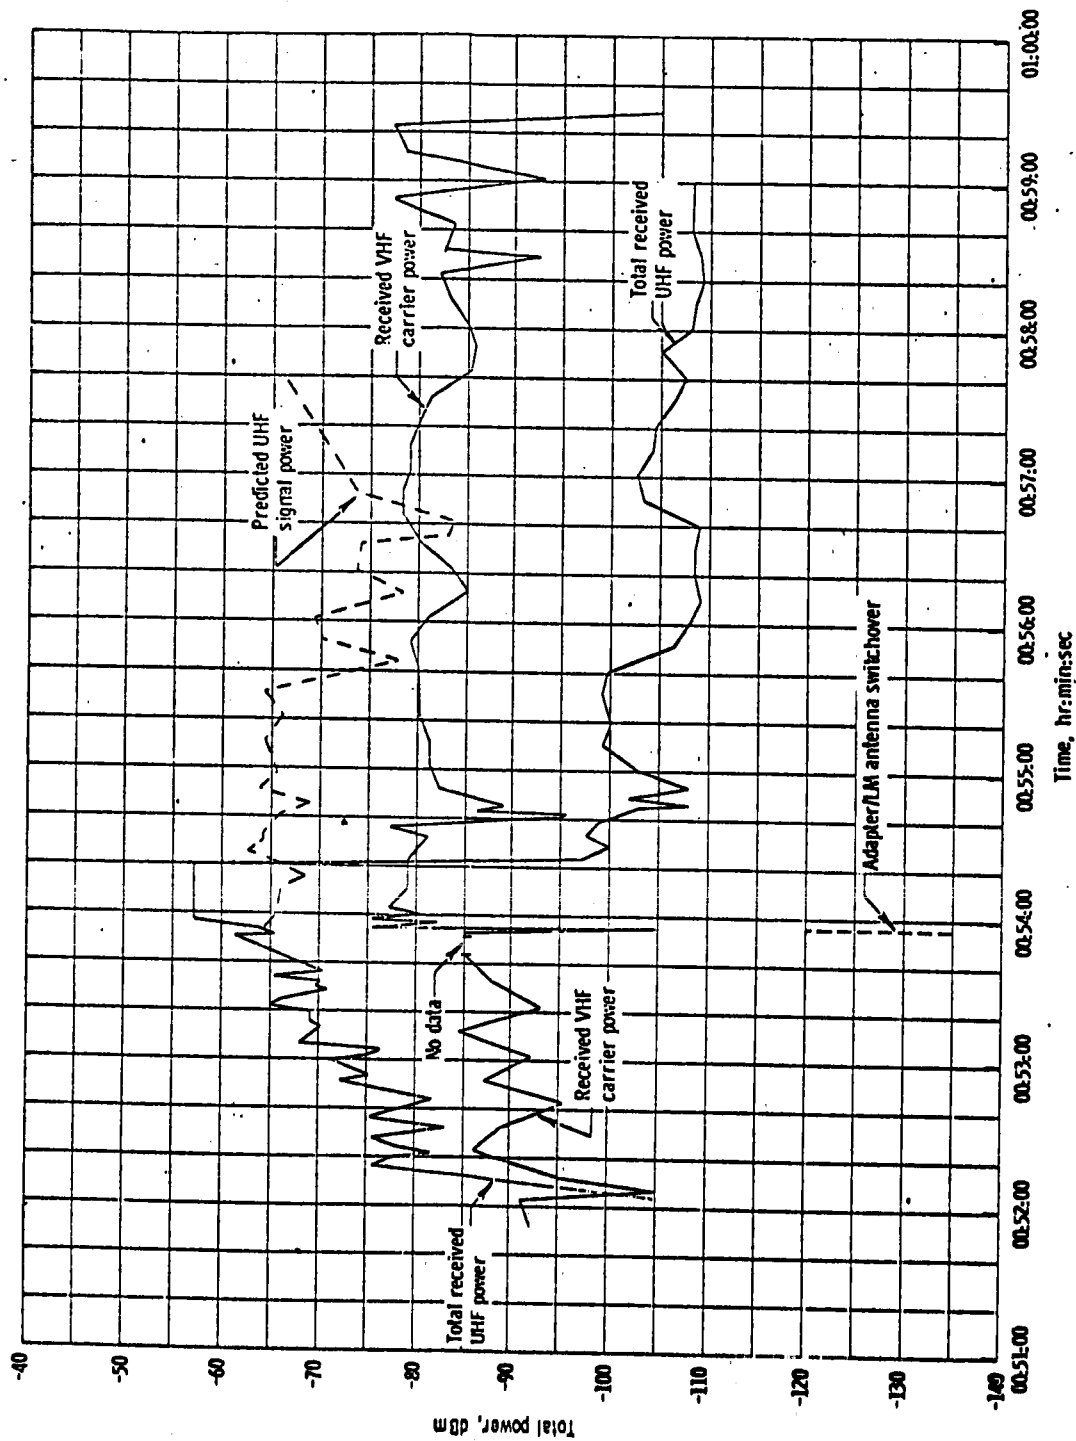
FIGURE 5 Total received UHF and VHF power, Carnarvon, revolution 1.

These abrupt changes of about 30 - 40 db in spacecraft received UHF signal strength were detected throughout the mission. Corresponding changes did not occur in the ground received signal strength from the VHF data transmitters which shared the same two antennas through a diplexer. These abrupt changes in received power frequently caused the received command signal power to be below the message acceptable threshold. Consequently, command transmission had to be delayed or repeated. Figure 5 shows typical signals.

The received signal power variations are consistent with an intermittent condition in either the digital command assembly RF stage, the coaxial cable assembly connecting the diplexer and digital command assembly, or in the internal diplexer connections. (Reference 10, page 6-8)
